**PHASE I ENVIRONMENTAL SITE ASSESSMENT  
BOLSA CHICA MESA PROPERTY  
HUNTINGTON BEACH, CALIFORNIA**

**JUNE 1996**

**EARTH TECH, INC.  
2121 ALTON PARKWAY, SUITE 100  
IRVINE, CALIFORNIA 92714  
PROJECT NO. 96-5020.02**

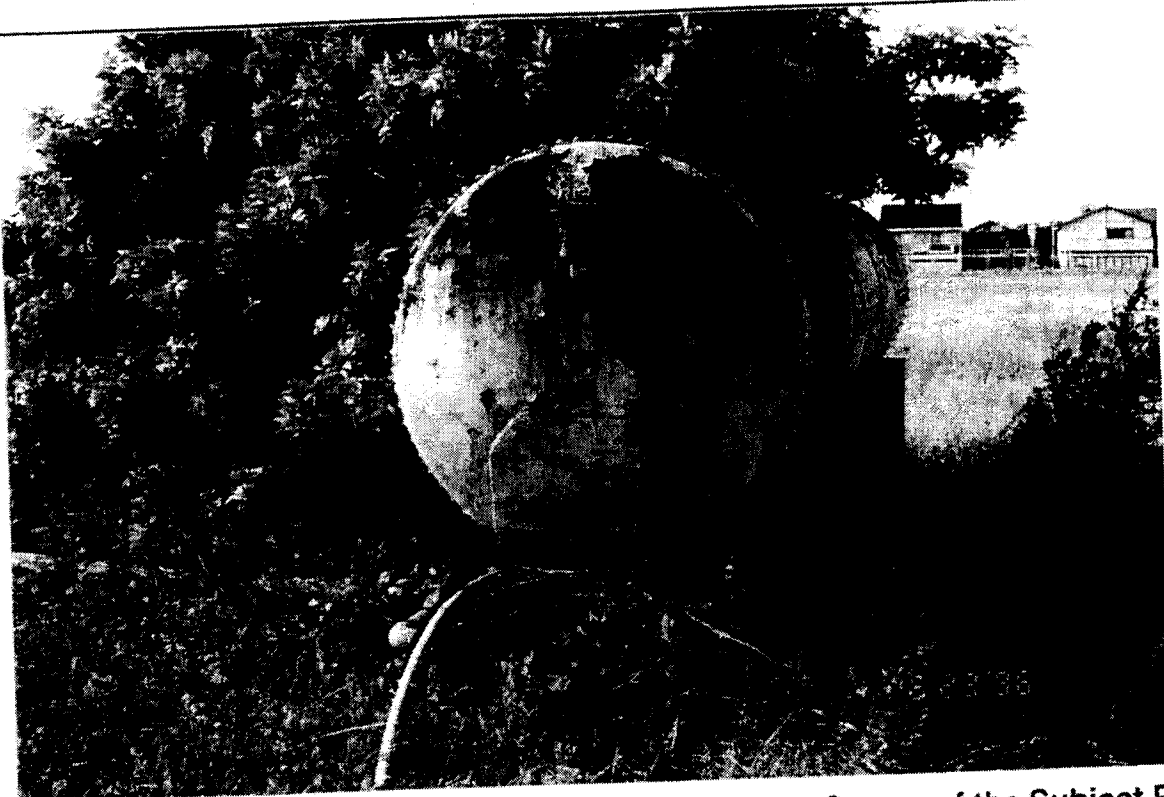
**Photo #3 Above Ground Steel Storage Tank in the Northeast Corner of the Subject Property**

A 20 feet long cylindrical aboveground storage steel tank was observed at the northeast corner of the subject property (Photograph #3). The top surface of the tank was rusted and no holes or punctures were observed on the tank. No signs nor labels were observed on the tank indicating the purpose for which the tank was used. The contents of the tank and the purpose of tank usage is unknown. No spills nor staining was observed on the soil surrounding the tank. In addition, a disconnected, old electrical panel was observed in an enclosure adjacent to the aboveground storage tank.

2. A fuel dispenser/pump, an aboveground concrete clarifier, and an aboveground steel tank were observed on the property. Soil sampling and laboratory analyses of soil samples is recommended to assess the potential presence of contaminants in the vicinity of these areas.

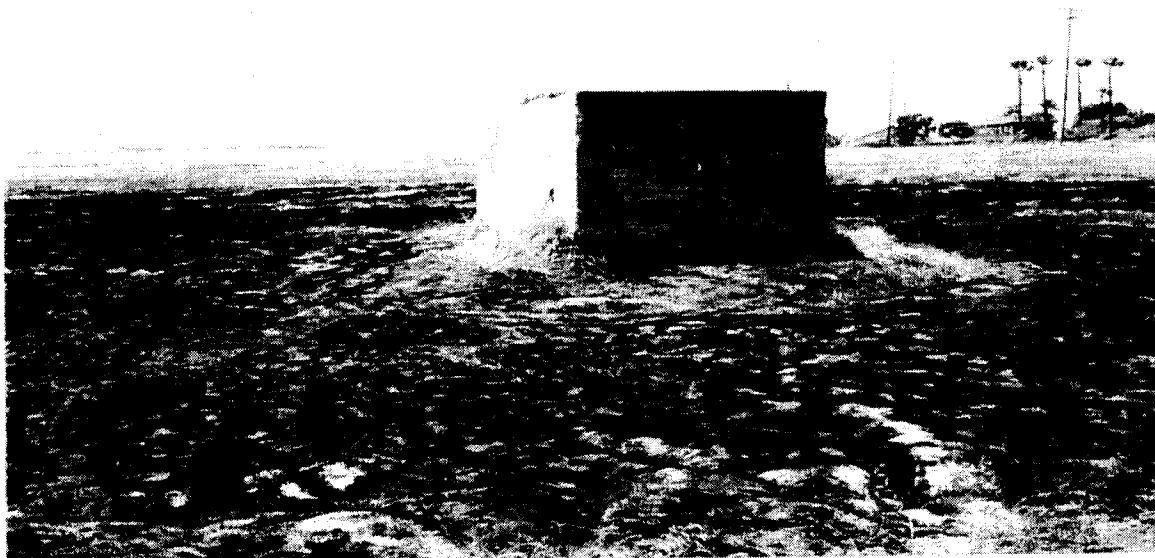
**Photo #5 Above Ground Concrete Clarifier in the North Central Area of the Subject Property**

An inactive 20 feet by 8 feet reinforced concrete three stage clarifier type structure was identified on the subject property at the northcentral area (Photograph #5). No chemical spillage nor staining was observed in the immediate vicinity of the clarifier. Household trash, beer bottles, soil, and weeds were observed inside the clarifier. The brush surrounding the clarifier appeared to be burnt.
